Advanced Technology Composite Fuselage—Materials and Processes

*D. B. Scholz, E. F. Dost, B. W. Flynn, L. B. Ilcewicz, K. M. Nelson, A. J. Sawicki,
and T. H. Walker*
The Boeing Company • Seattle, Washington

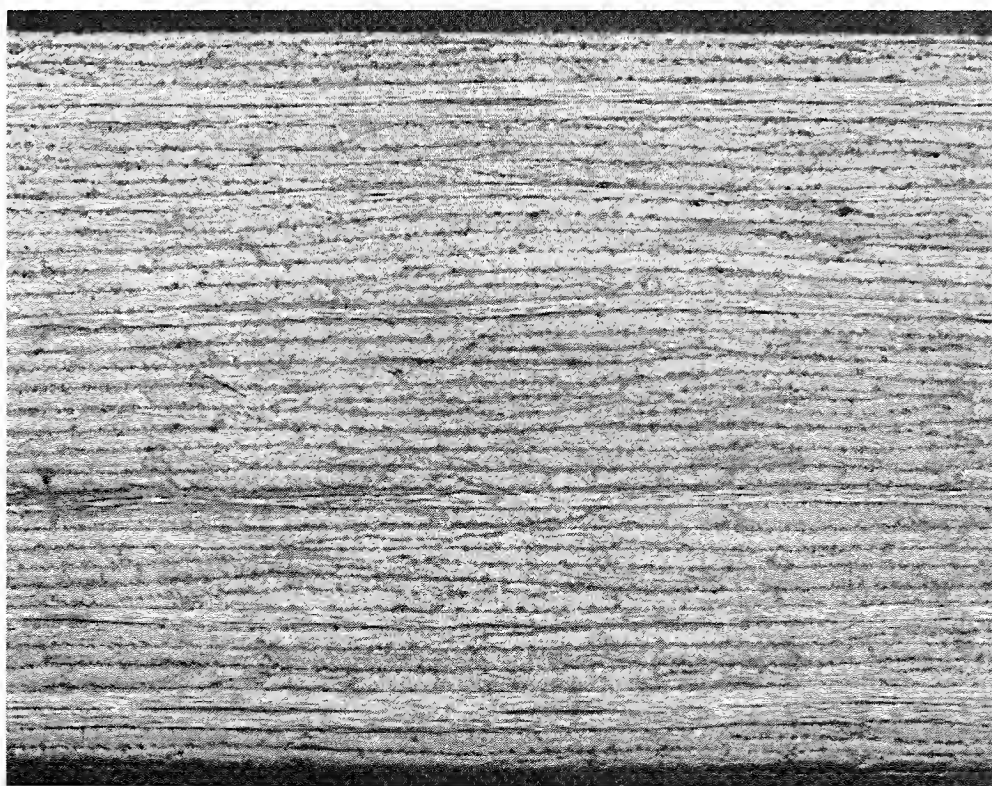
The AS4/8553-40 was used in an attempt to fabricate an interlayer particulate-toughened material for the keel. The ribbonizing action of the BCA head resulted in dispersion of the toughening particles throughout the carbon plies as shown in Figure 4-5. The merits of this microstructure were not evaluated. Fiber placement of AS4/8553-40 was not pursued further because of reports of excessive wear in AFP machine components from the toughening particles.

Figure 4-5. Microstructure of an AS4/8553-40 Interlayer Particulate Toughened Laminate Fabricated with the Automated Fiber Placement Process (BCA Head).
